## 737 GRAPHITE COMPOSITE FLIGHT SPOILER FLIGHT SERVICE EVALUATION

FIRST ANNUAL REPORT  
JULY 1973 THROUGH MARCH 1975

Prepared under contract NAS1-11668 by  
BOEING COMMERCIAL AIRPLANE COMPANY  
P.O. Box 3707  
Seattle, Washington 98124

May 1975

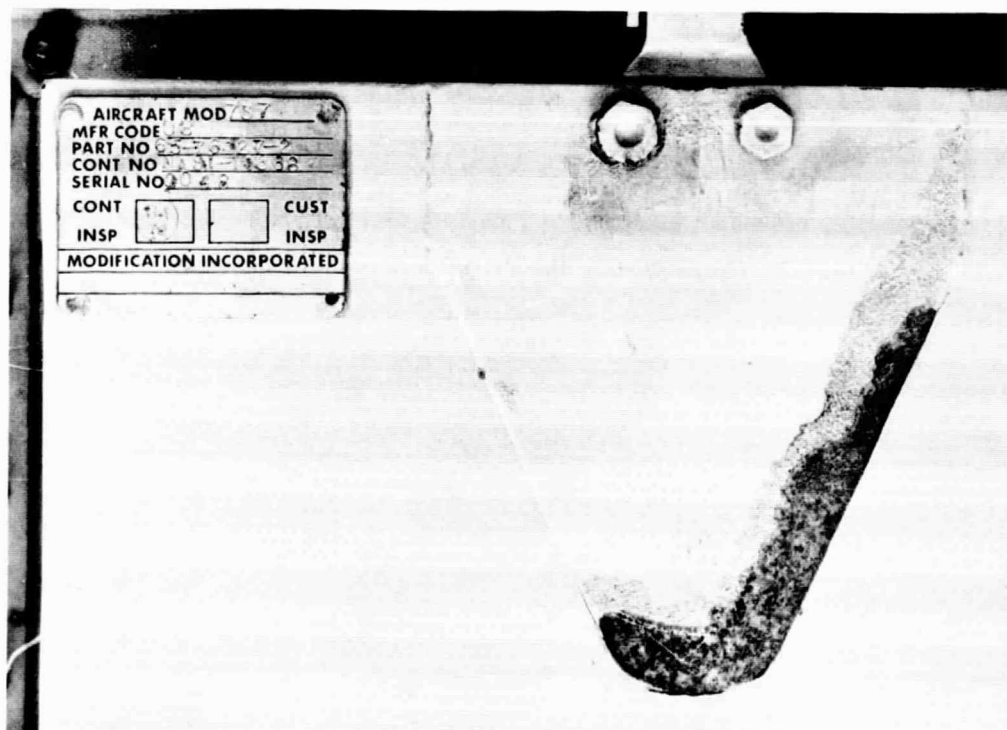
*Figure 6.—Corrosion on -23 Doubler*

the laminates points out very clearly that extreme caution must be exercised to avoid undesired forced displacements of the laminates. No evidence of corrosion or deterioration of the skin laminates has been observed. One case of corrosion of the aluminum bearing doublers on the spoiler lower skin was observed (spoiler S/N 0048, fig. 6). Investigation of this condition is continuing.

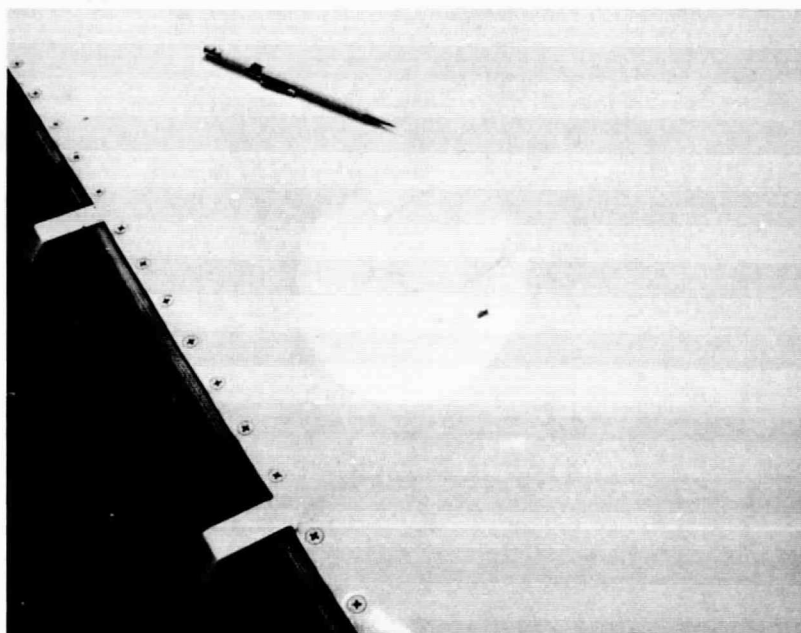
*Figure 7.—Upper Surface Repair Delamination on S/N 0014*

Five spoilers were selected at random for removal following the first year of service. Visual inspection of these units showed no detectable defects and only the oil and dirt associated with trailing edge components, except for spoilers S/N 0014 and 0104. Spoiler S/N 0014 showed evidence of delamination of a repair on the upper surface skin above the center hinge fitting (fig. 7). Spoiler S/N 0104 showed an upper surface skin blister, approximately 3 cm (1.2 in.) in diameter, above the center hinge fitting (CHF), which was not repaired prior to its destruction in static test.

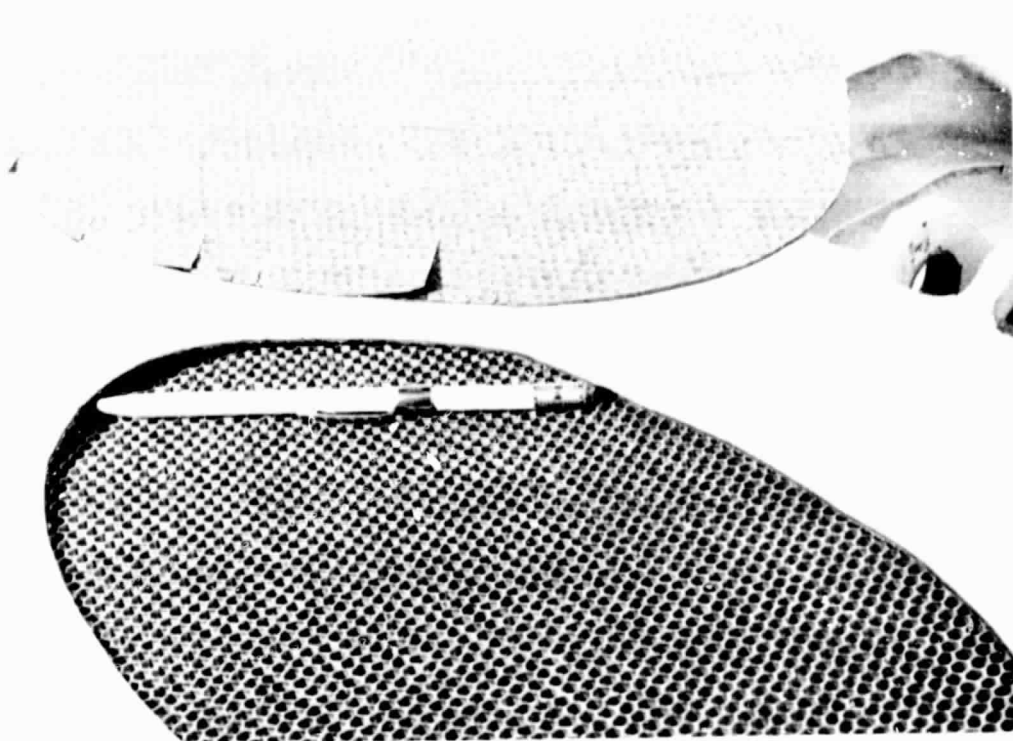
*Figure 14.—Skin Removed From S/N 0024*

In one instance (S/N 0024), the spoiler, with the upper skin repaired, was not placed in the bonding assembly tool. Instead, a partial bag was prepared covering the repair only. Following autoclave cure and bag removal, a large oval-shaped void, approximately 20 x 30 cm (7.8 x 11.7 in.), was visually noted in the central portion of the lower skin.

The color scan which followed the repair confirmed the void. To visually assess the problem, an oval section of skin was removed (fig. 14). Further examination disclosed that those areas adjacent (in the spanwise direction) to the initial void were also voided or weakly attached. Progressive removal of the entire lower skin was successfully accomplished (fig. 15). An entire new lower skin was successfully bonded to the spoiler frame, with the subsequent NDT inspection showing a void-free bondline. Following the repainting and reinstallation of details, the spoiler was returned to service.

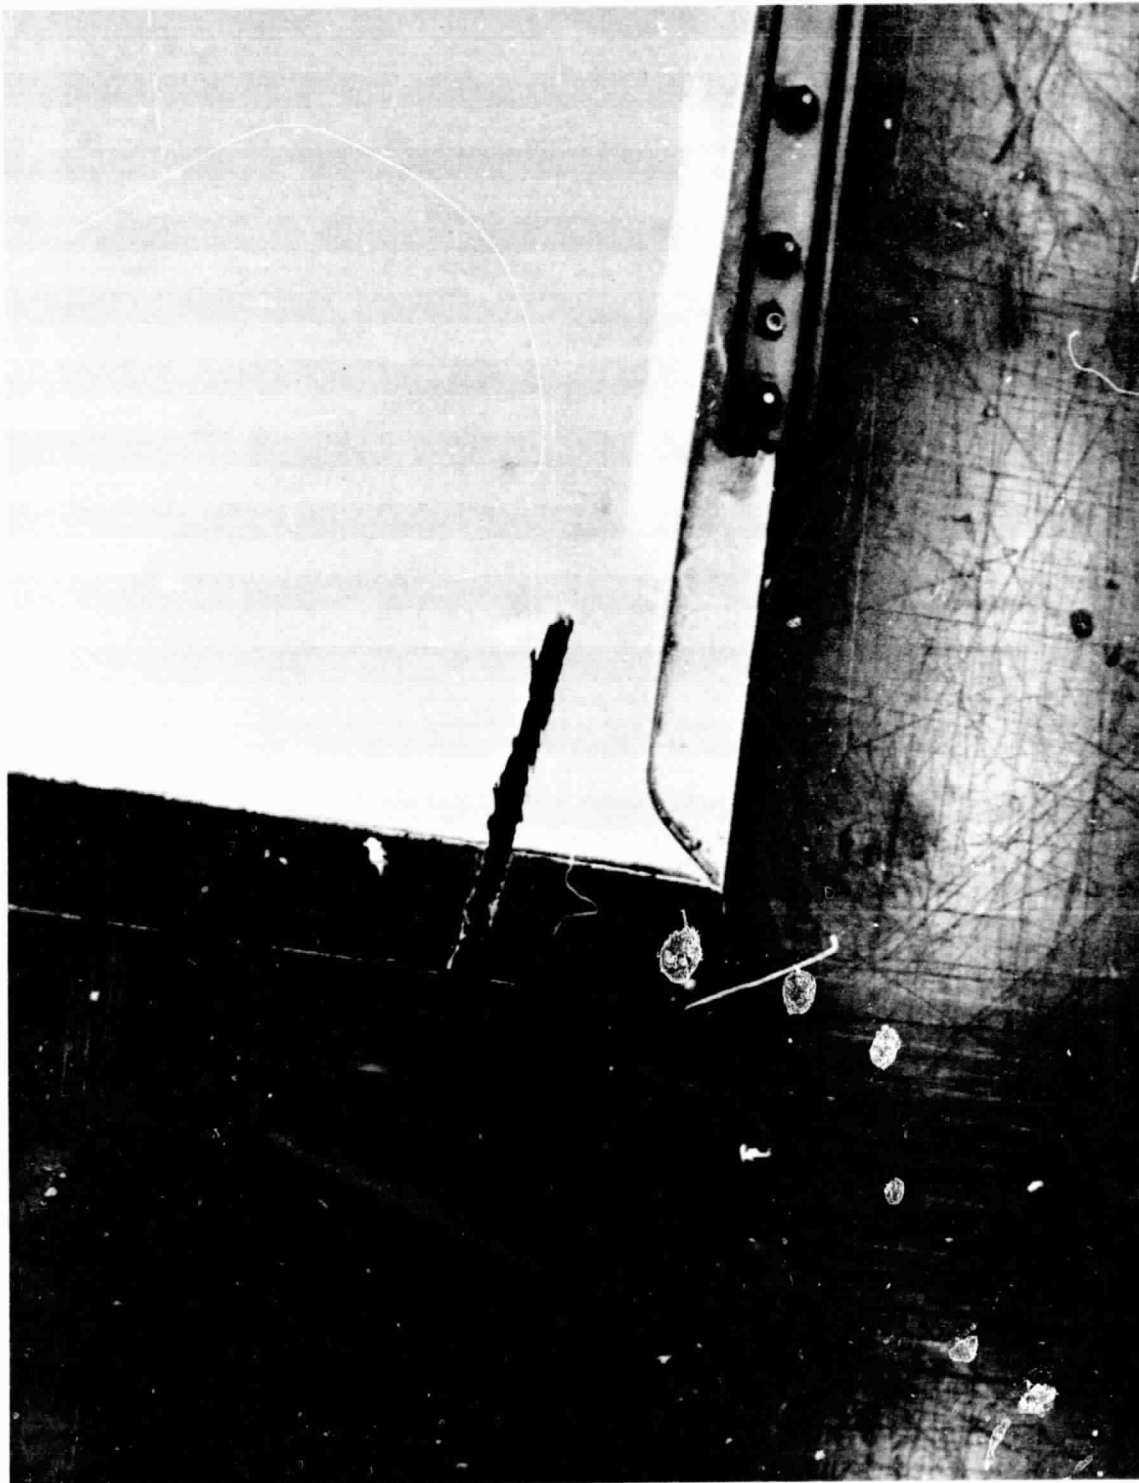
*Figure 16.—Damaged Trailing Edge of S/N 0089*

In June 1974, New Zealand National Airways reported that spoiler S/N 0089 had been inadvertently damaged by a control cable during aircraft overhaul. The nature of the damage was a slot cut through the spoiler thickness for a length of approximately 6.6 cm (2.6 in.) from the trailing edge. This damage has been repaired by Boeing, and the spoiler has been returned to National Airways and reinstalled.

Photos of the New Zealand spoiler (S/N 0089) show the damaged trailing edge before repair (fig. 16) and after repair (fig. 17).
